CASE STUDY: Emergency Repairs

Product: Primary Rotary Hammer Crusher

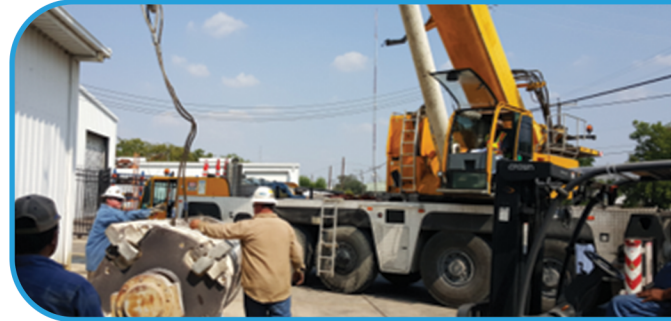
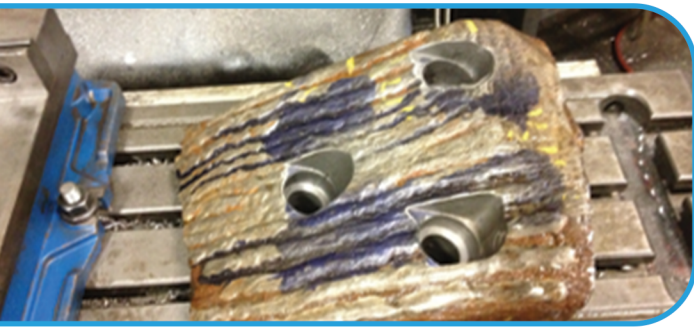
- ✓ Wedge Clamp Support Anvil broke off the main rotor.
- ✓ After Anvil broke the hammer was bouncing and damaged the rest of the rotor.
- ✓ Operations was shutdown with cost and lead-time for a new rotor to be procured.

- ✓ Poor clamping arrangement.
- ✓ Inadequate hammer back face support.
- ✓ Worn out rotor datum areas that retain hammer reliability.

- ✓ Design mechanical clamping process.
- ✓ Research base material for weld procedures on rotor base.
- ✓ Provide stress relief techniques to prevent weldment cracking.
- ✓ Weld hard facing.
- ✓ Install new hammers.
